Loveland Historic Preservation Commission Staff Report

From: Marc Cittone, Community and Strategic Planning
Meeting Date: April 21, 2008
Re: Application for Historic Landmark Property Designation

Address: 411 W 5th Street, Loveland, Colorado

Historic Name: F.M. Samuels House

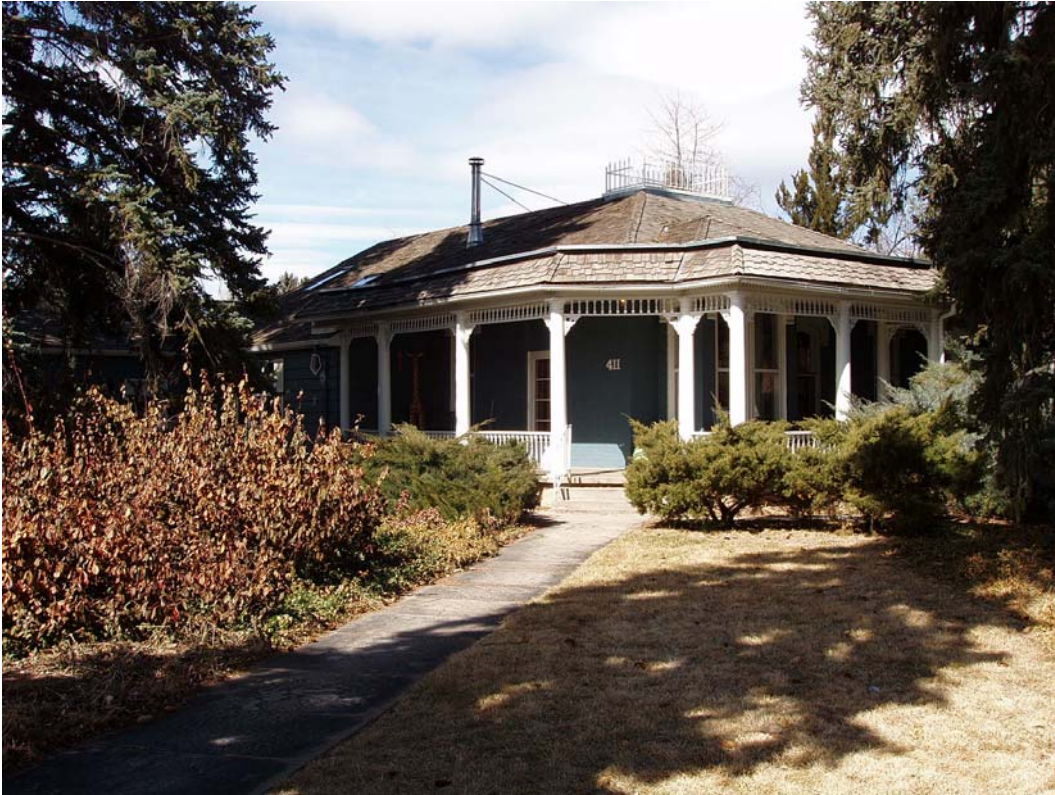
Southeast corner

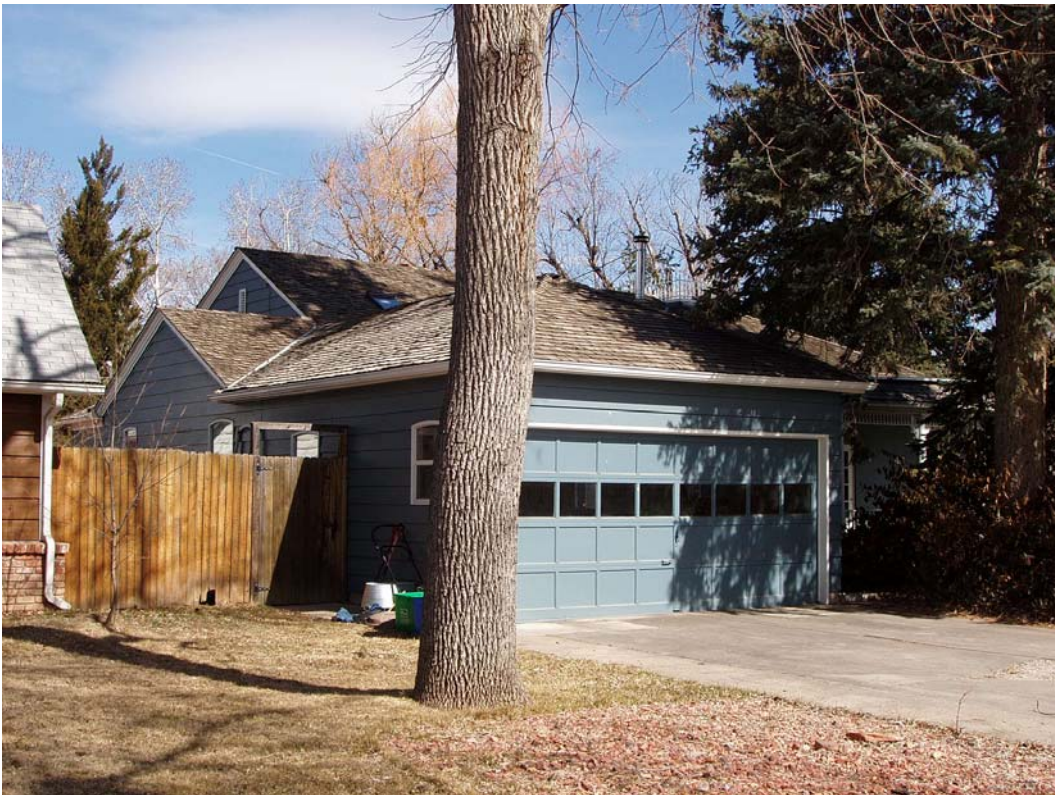
Southwest corner

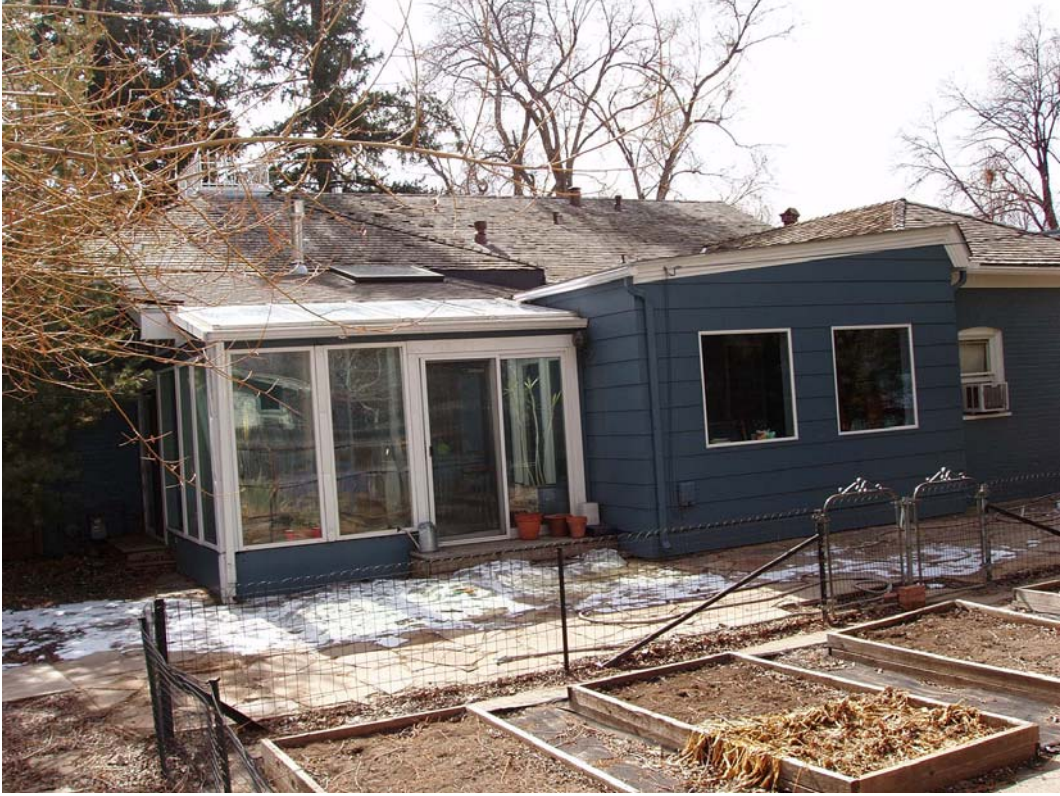
Northeast corner, east portion

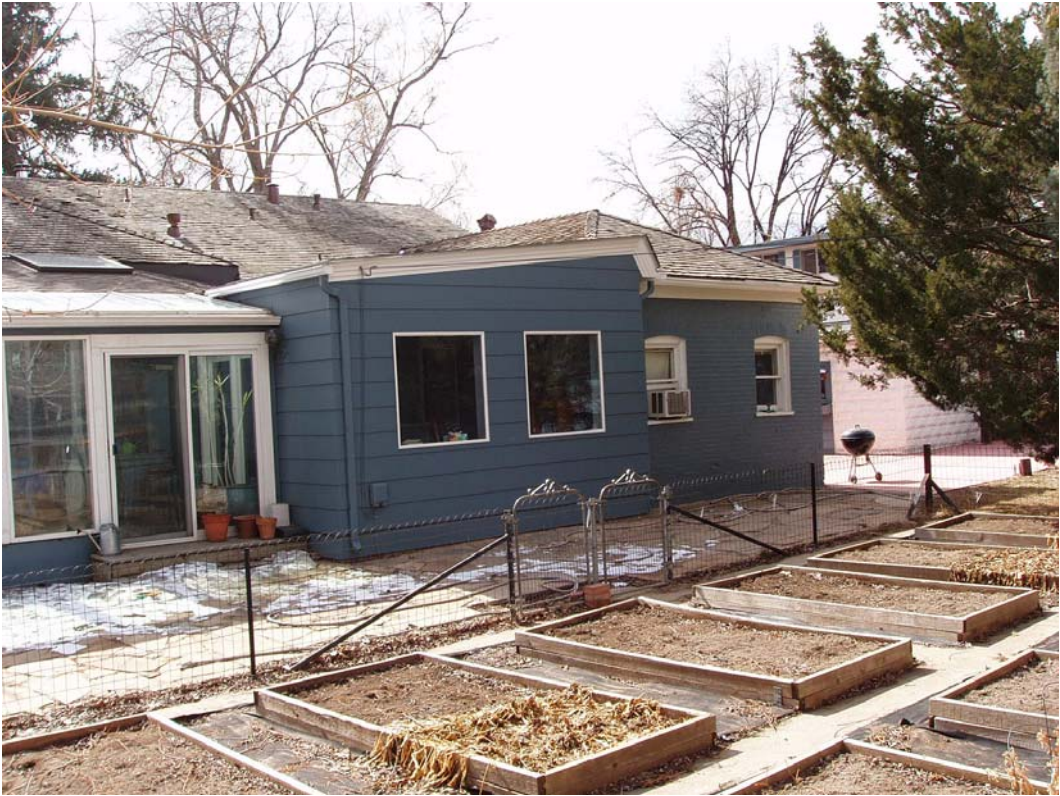
Northeast corner, west portion

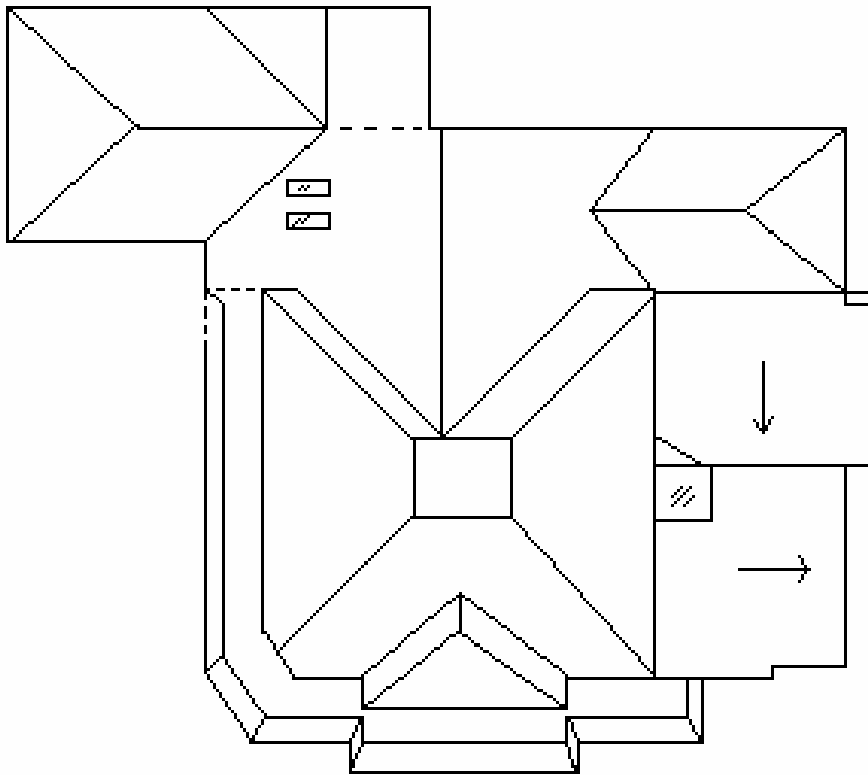
Roof Plan-not to scale

This single story, brick and wood frame, Eclectic Victorian residence on a stone foundation has a complex roof system of hip, gable, mansard, and shed roofs covered with wood shingles. (See attached roof plan.) The original hip roof with a crested widow's walk stands as the eastern portion of the structure. Along this same hip portion, a mansard roof covers the porch that wraps around the southern and eastern portions of the original structure. Three steps up from the ground level on the southeast corner allow access to the porch but the wood framed, glass main entrance door sits west of this approach. Carved spindles line both the roofline and the edge of the raised concrete floor of the porch between modified Doric columns; the top spindles are miniature versions of the spindles from the balustrade. Tall, double-hung, rectangular windows stretch from the porch floor almost the full height of the wall, allowing just enough room for a decorative entablature over the window. The portion of the house under this hip

Extending west from the original hip roof is a gable roof that covers a small pentagonal window next to a double-hung window on the south façade before the garage extends south under a hip roof with approximately a one foot overhang. This section also has two flat skylights and a large galvanized metal ventpipe on the gable roof of the main portion of the residence. The double garage door has four rows of eight panels with the second row from the top consisting of square fixed windows. The garage intersects with a one room addition under a gable roof. These two rooms also extend west beyond the gable end of the main portion of the residence. Along the west façade of the garage, the one room addition, and the main gable end are 2' x 3' double-hung segmented arch windows. A small louvered vent sits just under the cornice of the main gable end (there is no overhang on the gable ends).

From directly under the main gable peak on the west façade and extending north is a one room section of brick, followed by a wide passageway filled in with horizontal lap siding around a door and another brick room under a hip roof. This brick room also has double-hung windows set in segmented arches. Numerous small metal ventpipes protrude from the roof of this room and the adjacent area. Another addition abuts this brick room on its eastern side but extends a couple feet further north and has a shed roof sloping east (the extension beyond the brick room has a very steep gable). This room has two large fixed pane windows. On the east side of this room, sits a solarium. The solarium's shed roof slopes down to the north from its intersection with the hip roof just behind the porch. The first half of the roof has wood shingles with a flat skylight but the lower half has four solar panels covering the entire width of the roof.
