Viestenz-Smith Mountain Park

Grand Re-Opening | September 28, 2018

Reconstruction

Rebuild for Resiliency

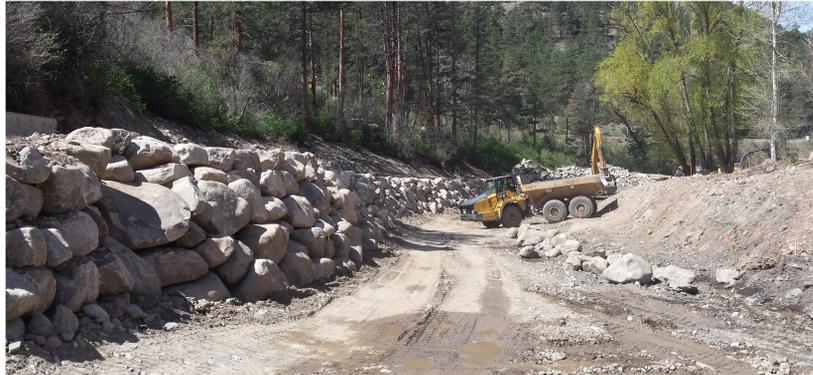
New River Channel with Geogrid Reinforced Boulder Wall (left) along Sharp River Bend for Scour Protection

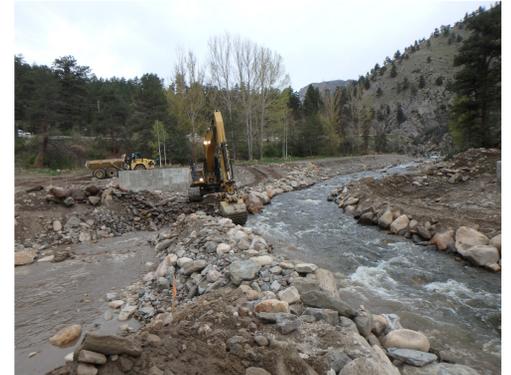
Western Confluence of the New (left) and Old (right) River Channels

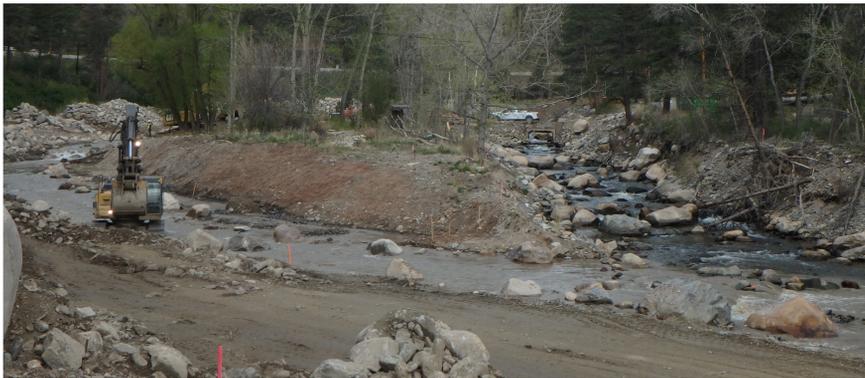
Eastern Confluence of New (left) and Old (right) River Channels

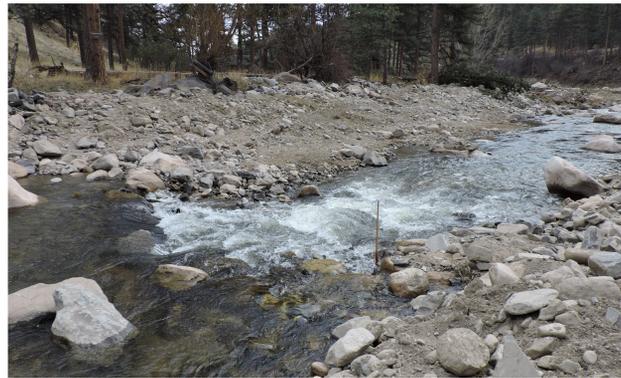
Boulder Drop Structure to Slow and Guide Water in New River Channel

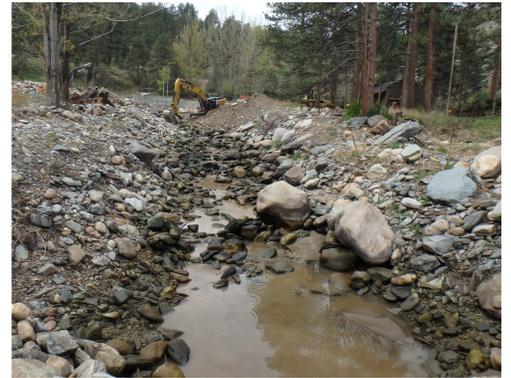
Filling the Old River Channel

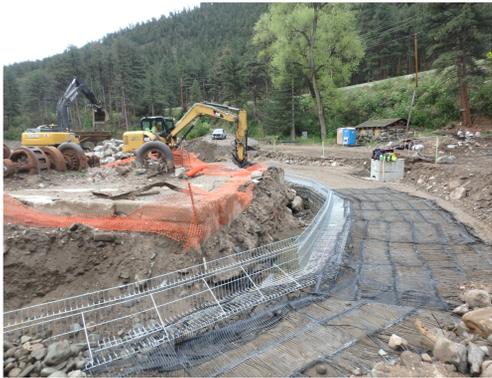
Geogrid Reinforced Subgrade at Parking Lot

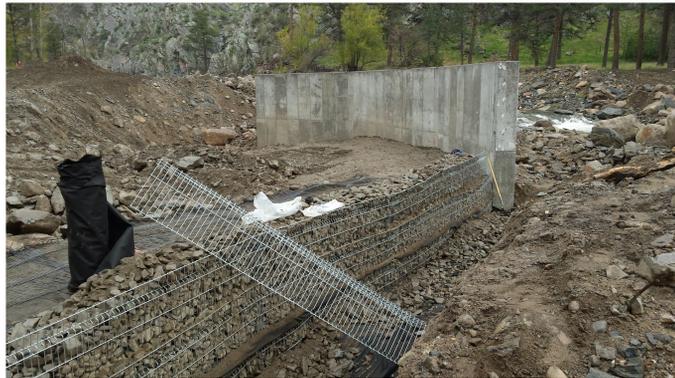
Geogrid Reinforced Retaining Wall and Bridge Abutment Anchored into Bedrock through Micropiles

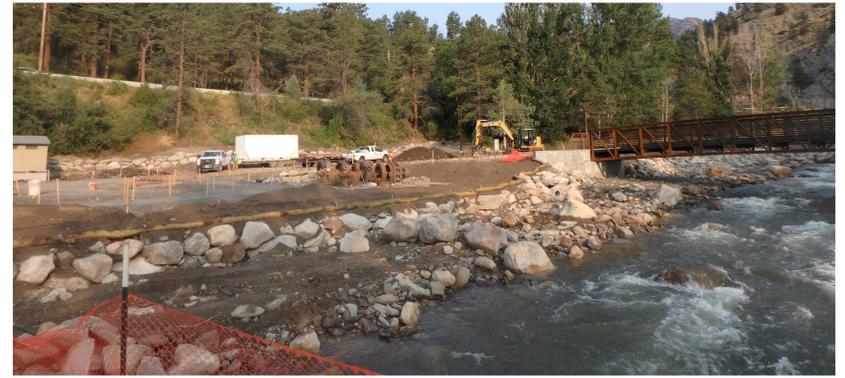
Stacked Boulder Wall Lining Geogrid Reinforced Wall at Parking Lot to Create a More Natural Aesthetic

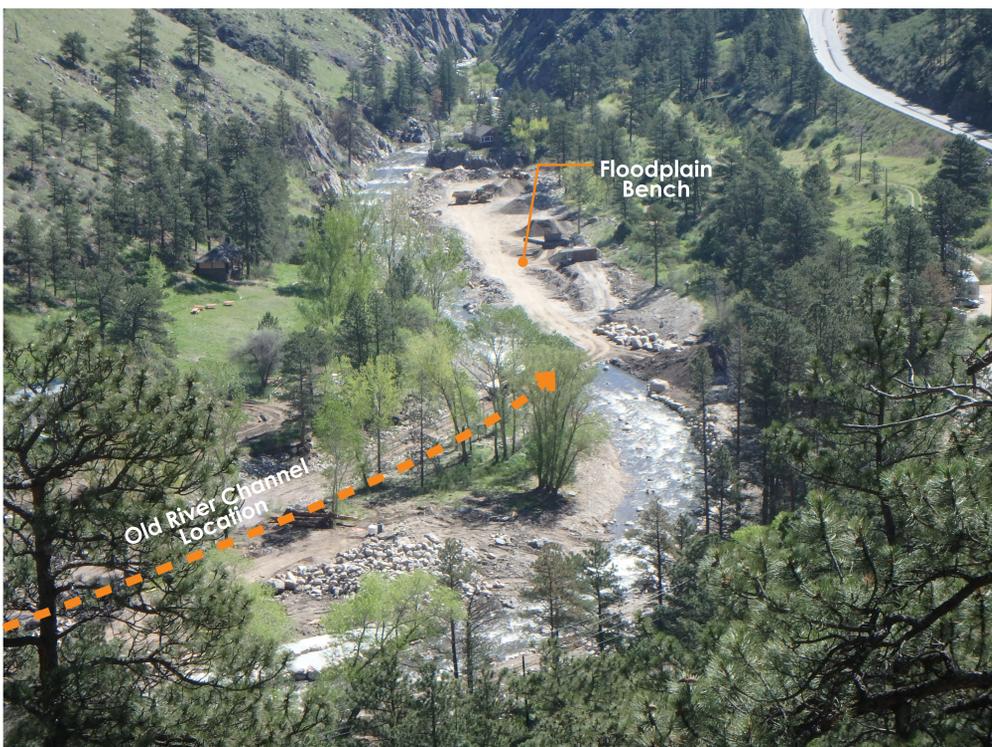
New River Channel and Floodplain Bench to Accommodate Water when the River Overtops

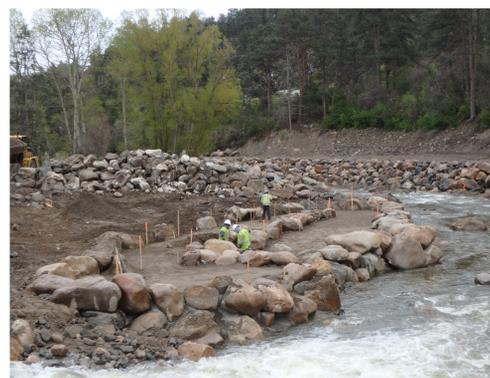
ADA Accessible Terraced Fishing Platform Designed to Accommodate Spring Runoff Flows and Allow Fishing on Multiple Levels

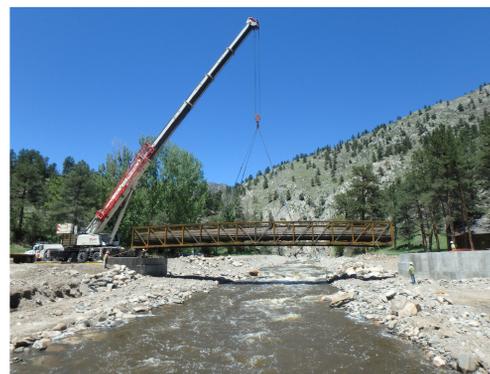
Placement of 100' Long Bridge

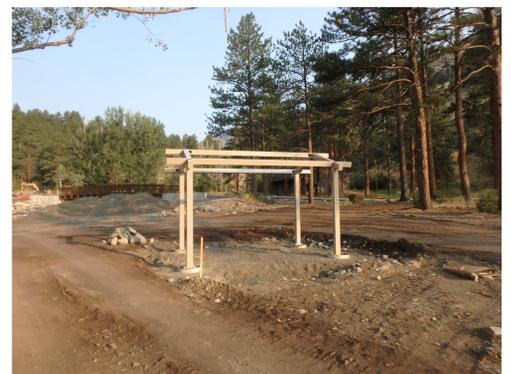
Skeleton of Picnic Shelter During Construction
